UNDERWATER BRIDGE INSPECTION REPORT

STRUCTURE NO. L5733
ABANDONED RAILROAD
OVER THE
MISSISSIPPI RIVER
DISTRICT 5 - HENNEPIN COUNTY

PREPARED FOR THE
MINNESOTA DEPARTMENT OF TRANSPORTATION
BY
COLLINS ENGINEERS, INC.

JOB NO. 5221

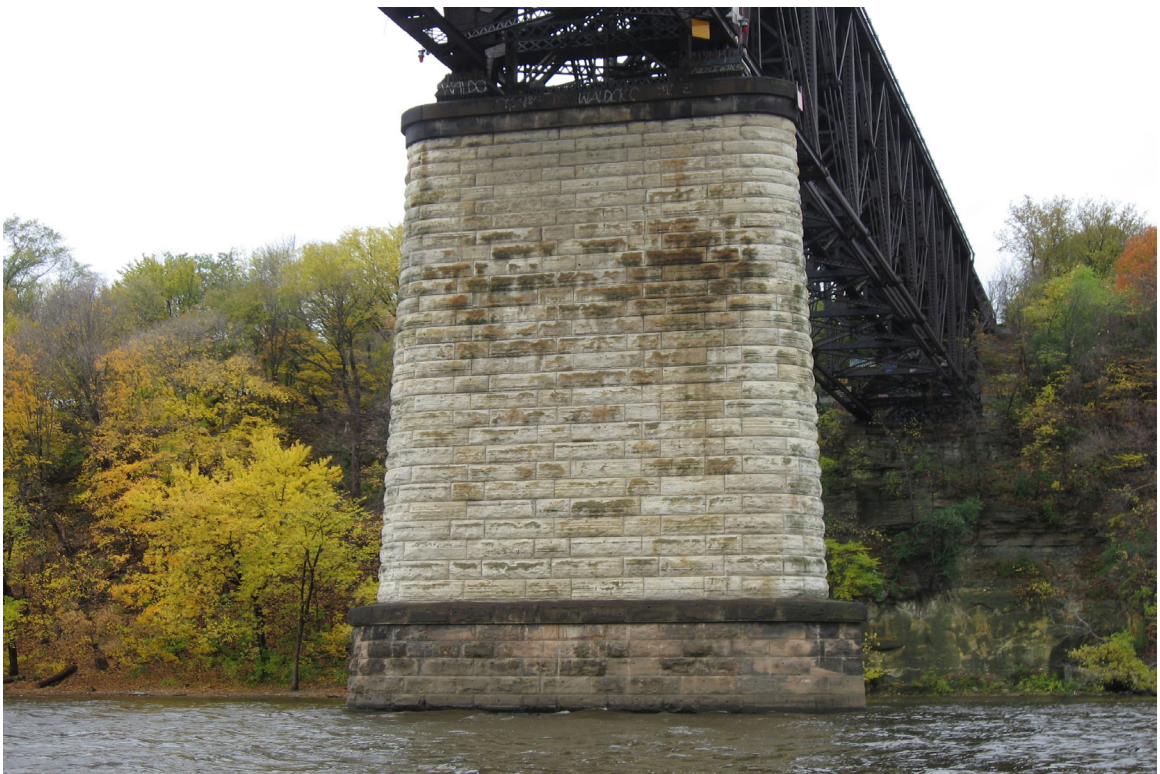
Photograph 2. View of West Pier, Looking West.

- (A) The top of the footing at the West Pier was exposed from the midpoint along the west face, around the upstream nose, and to the upstream quarter point along the east face, with 4 inches of maximum vertical face exposure detected at the upstream end.
- (B) Overall, the stone masonry was in good condition with only minor hairline cracks observed in the mortar joints at random locations.
- (C) A light accumulation of steel debris was observed scattered on the channel bottom around both piers.

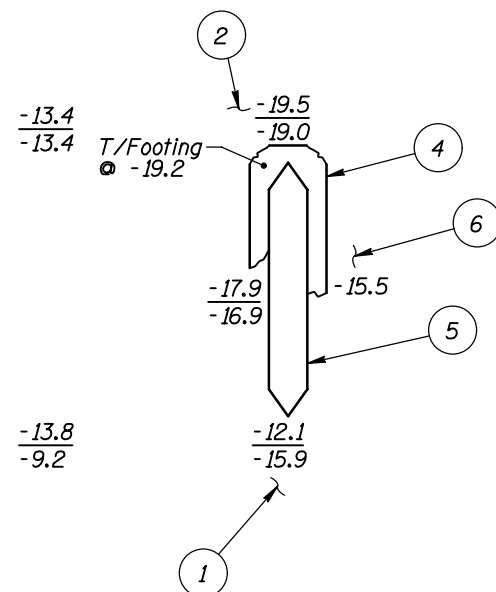
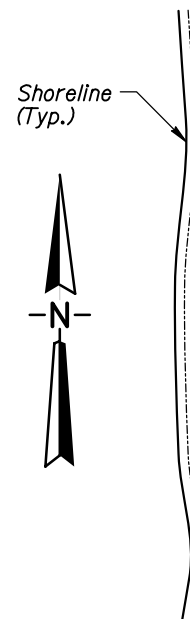
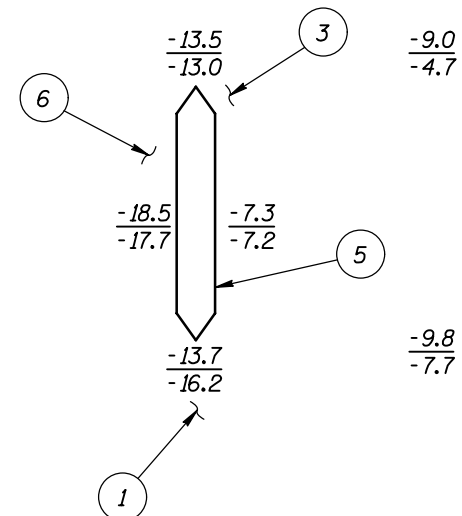
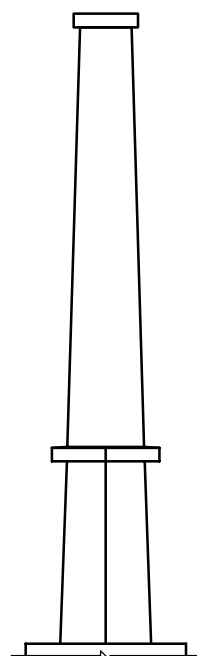
INSPECTION AND SOUNDING PLAN

- 1 The channel bottom consisted of sand infilling at the downstream end of both piers with up to 1 foot of probe rod penetration.
- 2 The channel bottom consisted of riprap from 1 to 2 feet in diameter at the upstream nose and 6 to 8 inch diameter riprap and sand along both sides of the West Pier.

- 3 The channel bottom consisted of riprap from 1 to 4 feet in diameter at the upstream nose and 6 to 8 inch riprap and sand along both sides of the East Pier.

- 4 The top of the footing was exposed from the quarter point along the west face, around the upstream nose, and to the midpoint along the east face with 4 inches of vertical face detected at the upstream end.

- 5 The stone masonry was in good condition with minor hairline to 1/8 inch (maximum) cracks observed in the mortar joints at random locations.
- 6 A light accumulation of steel debris was observed scattered on the channel bottom around both piers.
